Manhole Inspection Summary

Manhole # S47II_054MH

Record Plat: **47II** Node: **054** Status: **Found**

Location Address: **Federal st** Cross Street: **Patterson Park ave**

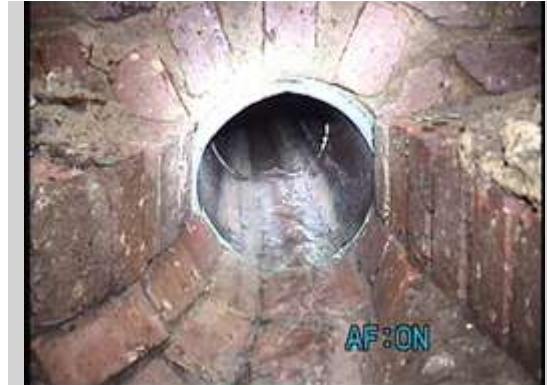
12 O'Clock Outflow
Pipe Out @ 12 O'Clock

Pipe Height: **12** (in.) Rod and Bar (Angled)
Pipe Material: **Clay** ☐ Pipe Lined
Invert Depth: **9.83** (ft.) Flow Characteristics: **Fast**
Deposits: ☒ None ☐ Mud ☐ Sludge ☐ Debris ☐ Grease
Silt Depth: (in.) Deposits Extent:
Infiltration: **None** Pipe Seal Cond: **Sound**
